CENTRAL ASHEVILLE WATERSHED RESTORATION PLAN

Blue Earth Planning, Engineering & Design, PC
1 Haywood Street, Suite 414
Asheville, NC 28801
www.blueearth.us

August 2020

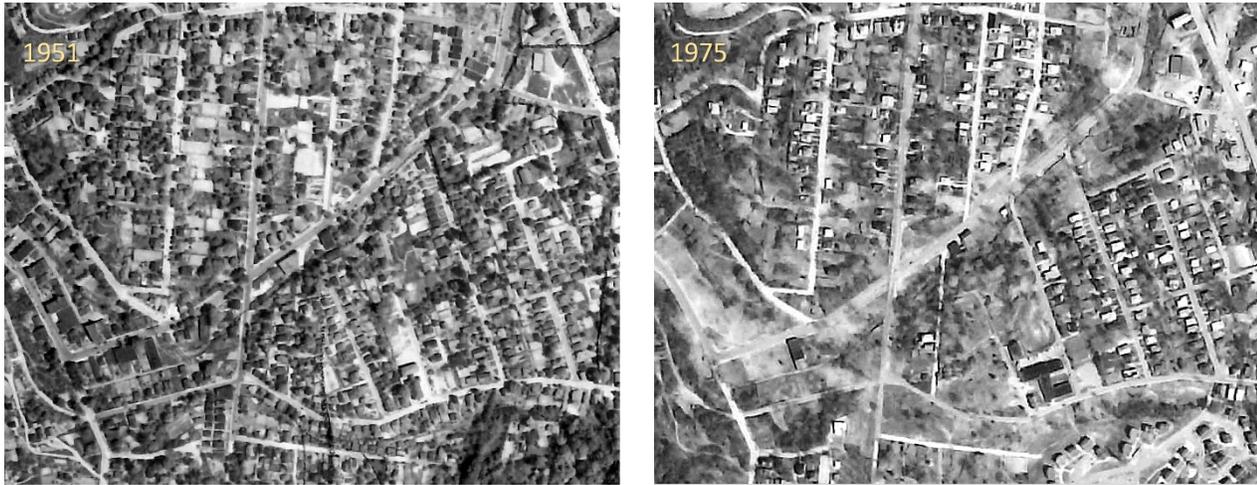
Figure 12 Changes in the vicinity of Nasty (now Town) Branch, 1951 - 1975

below showing an identical extent of Southside from 1951 (left) and 1975 (right) reveals just a fraction of the extensive demolition in the vicinity of Nasty Branch.

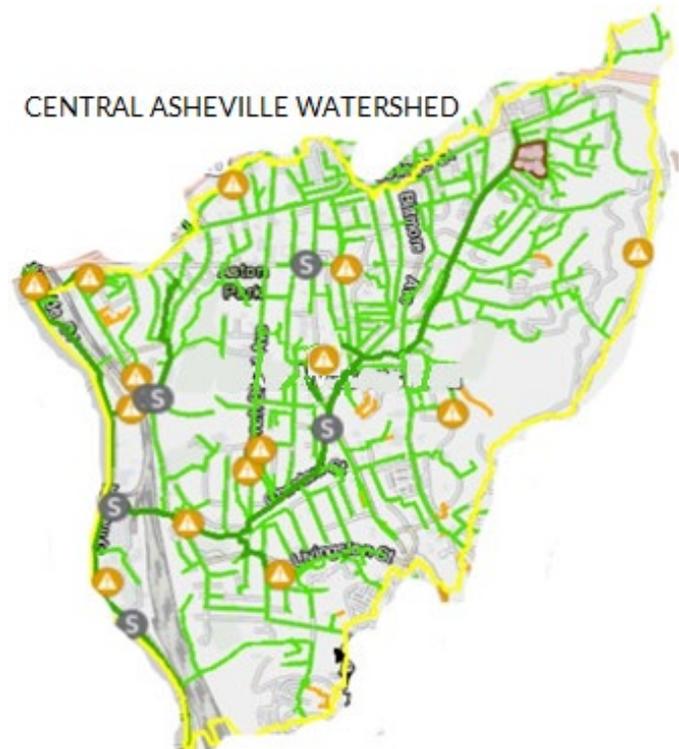
Figure 13 MSD Sanitary lines in the CAW and reports of SSO (denoted by an S) and Odor problems (denoted with triangles) in the past three years.

There are over 950 miles of sanitary sewer lines operated by the Municipal Sewerage District of Buncombe County (MSD), many miles of those lines are in the CAW. Figure 13 displays the location of the MSD lines in the watershed. By necessity, the sanitary sewer collection system follows the valleys from the upper reaches of the watershed to a large sewer main lying along the banks of the French Broad River. The proximity of the sewers to our streams, both above and below ground, means that any leakage or spillage in the system usually has an immediate impact upon the stream’s water quality, particularly bacterial loads carried by the stream. Later in this report is documentation of dry- and wet-weather e. coli and fecal coliform concentrations in the three primary streams in the watershed with each stream showing high levels of bacteria. Often a primary contributor to bacterial contamination in urban streams, particularly during periods of dry weather and low stream flows, is the sanitary sewer system. Urban stormwater runoff is a primary contributor during wet periods.

Figure 13 also illustrates the reported sanitary sewer overflows (SSOs) and the locations of sewer odor complaints investigated by MSD since April 2017. As measured against similar sized sewersheds in other North Carolina communities, there have been a relatively small number of SSO and odor complaint incidents. However, the concentration of the SSOs immediately adjacent to Town Branch and the French Broad River is a cause for concern.

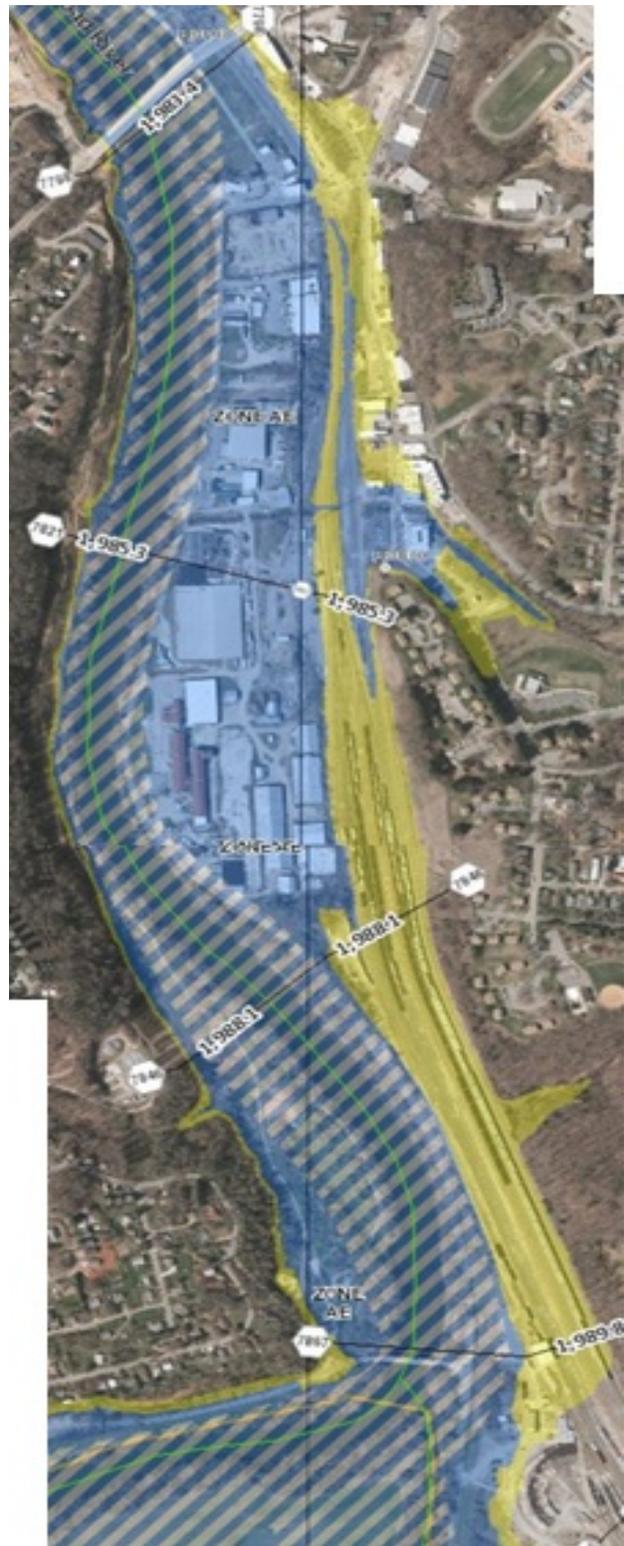
Figure 15 French Broad River Floodplain

The lower region of the CAW lies in the floodplain of the French Broad River. The figure to the right shows the current effective regulatory floodway, 100-year flood fringe and the 500-year flood fringe. Flooding along the French Broad and Swannanoa rivers in 1916, 1944 and 2004 caused extensive damage in the City and in the watershed. The Land of Sky Regional Council of Governments cooperated with the National Environmental Modeling & Analysis Center (NEMAC) to develop a regional assessment of flood hazards (<https://landofsky.acceladapt.com/>). The geographic unit encompassing the CAW estimated 8.6% of commercial properties in the area were exposed to flood hazards within the FEMA regulator floodplain. Other categories of flood hazard included: 0.5% of residential properties, 10.56% of natural or protected properties and 20.75% of government-owned and critical facilities.

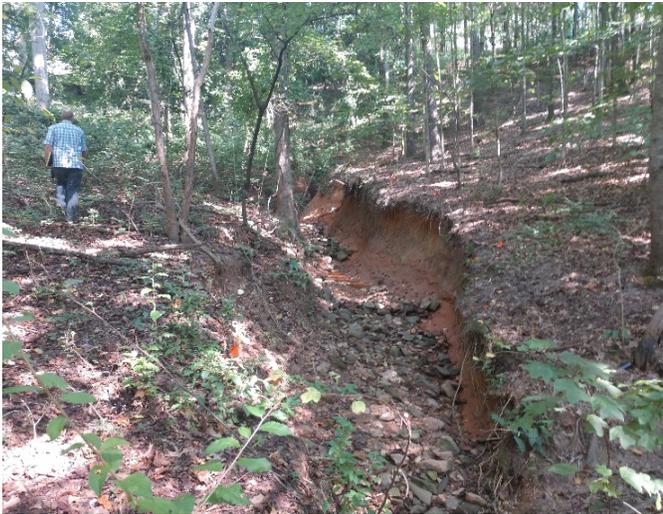
Figure 20 Severely eroded ephemeral channel downstream from A-B Tech stormwater outfall.

A major sediment source enters the creek left from a severely headcut and eroding ephemeral drainage originating on campus (see Figure 20 and Figure 21). During this project, that area was surveyed by A-B Tech students & staff – their data were used to develop a conceptual remedial plan and will be used for design of a recommended CAWRP implementation project based on Regenerative Stormwater Conveyance (RSC) techniques.

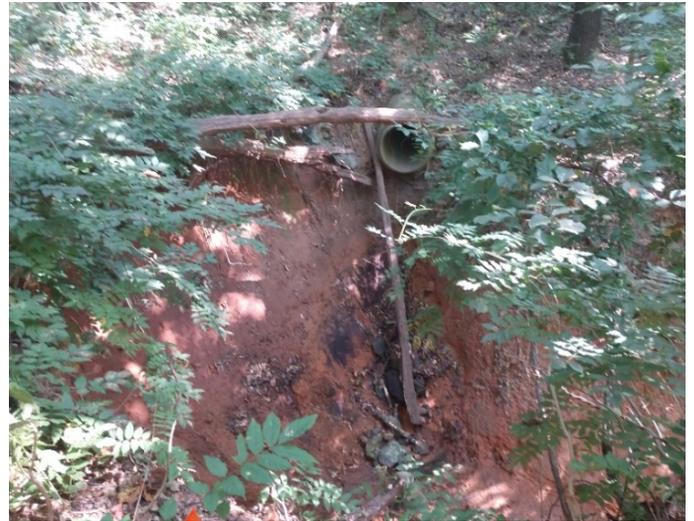
Figure 21 Perched stormwater outlet and 13 feet deep plunge pool below A-B Tech campus

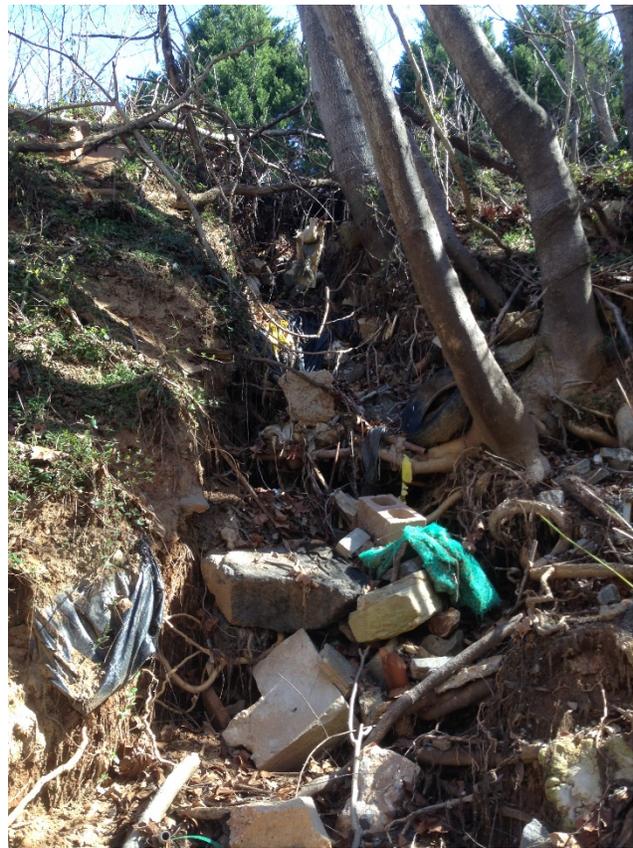
Figure 22 Eroding gully carries sediment and trash to Bacoate Branch

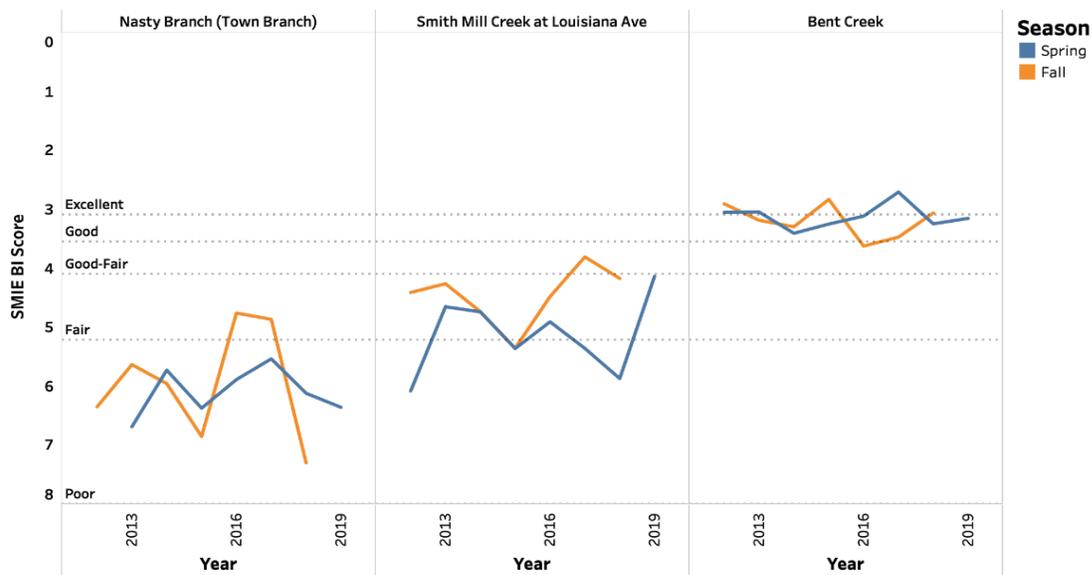
Figure 23 Macroinvertebrate Biotic Index Scores for Town Branch

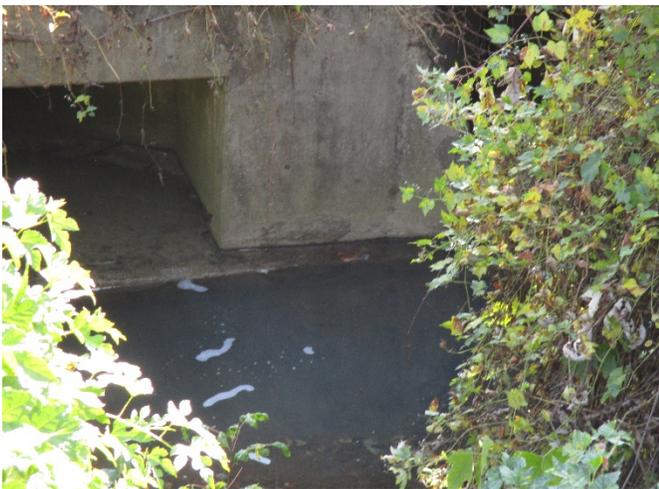
Figure 28 Black water from unknown source in Town Branch.

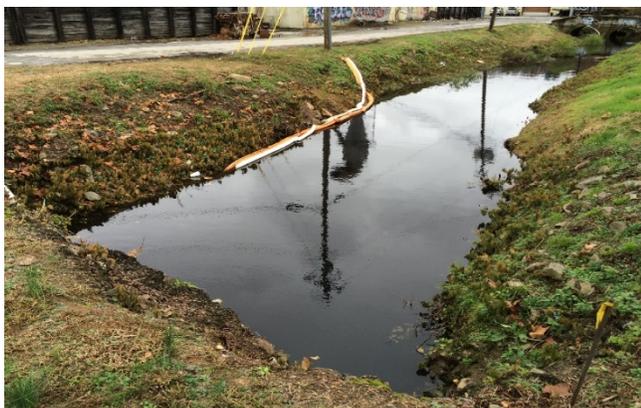
Figure 29 Black water in Town Branch near the French Broad.

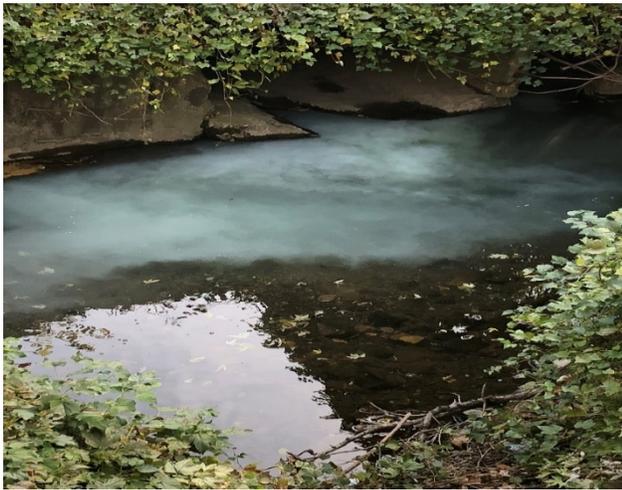
Figure 30 White water discharge into Town Branch.

- Washing of commercial vehicles immediately above a stormwater inlet without the use of inlet protection or other best management procedures.
- Inadequate erosion and sediment control measures at a construction site.
- Improperly stored material at a metal fabricating facility that led to a white water discharge to Bacoate Branch.

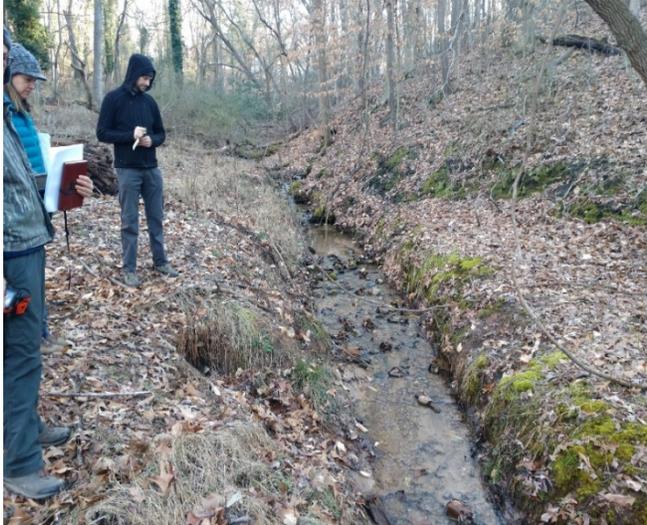
Figure 46 Haith Branch

Field observations made starting in September 2019 have identified several problem areas to address. The most significant physical problem is a large erosion plunge pool and gully that has formed below a 36-inch diameter stormwater outfall that drains parking lots and buildings on the A-B Tech campus. The gully begins in a 13 feet deep plunge pool and continues through a deeply eroded, channel. At the end of the eroded channel, flow spreads out into an area of deposition and debris through which a set of braided channels have formed. This area represents a safety hazard and contributes to

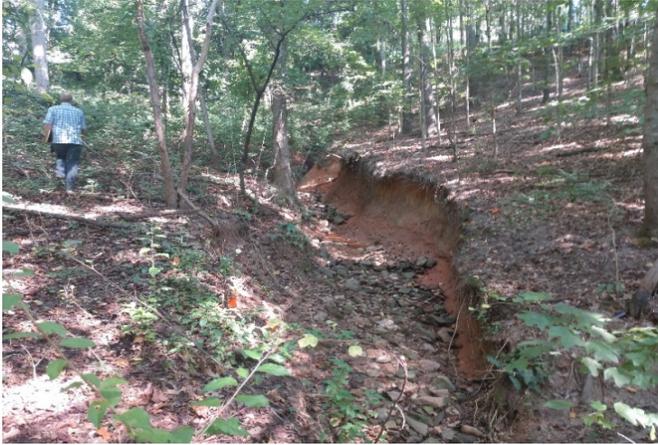
Figure 48 Deeply incised gully below plunge pool.

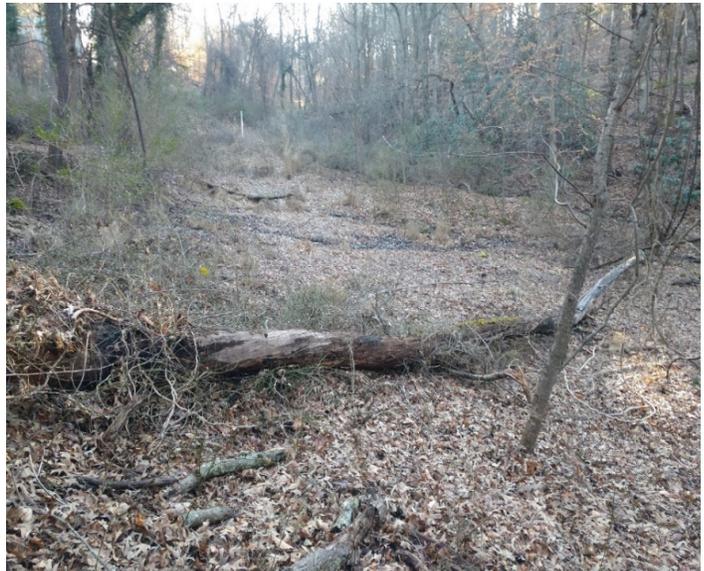
Figure 50 The watershed contains several "seeps" such as this one. The restoration and management of these areas would provide important native plant, amphibian, and other wildlife benefits.

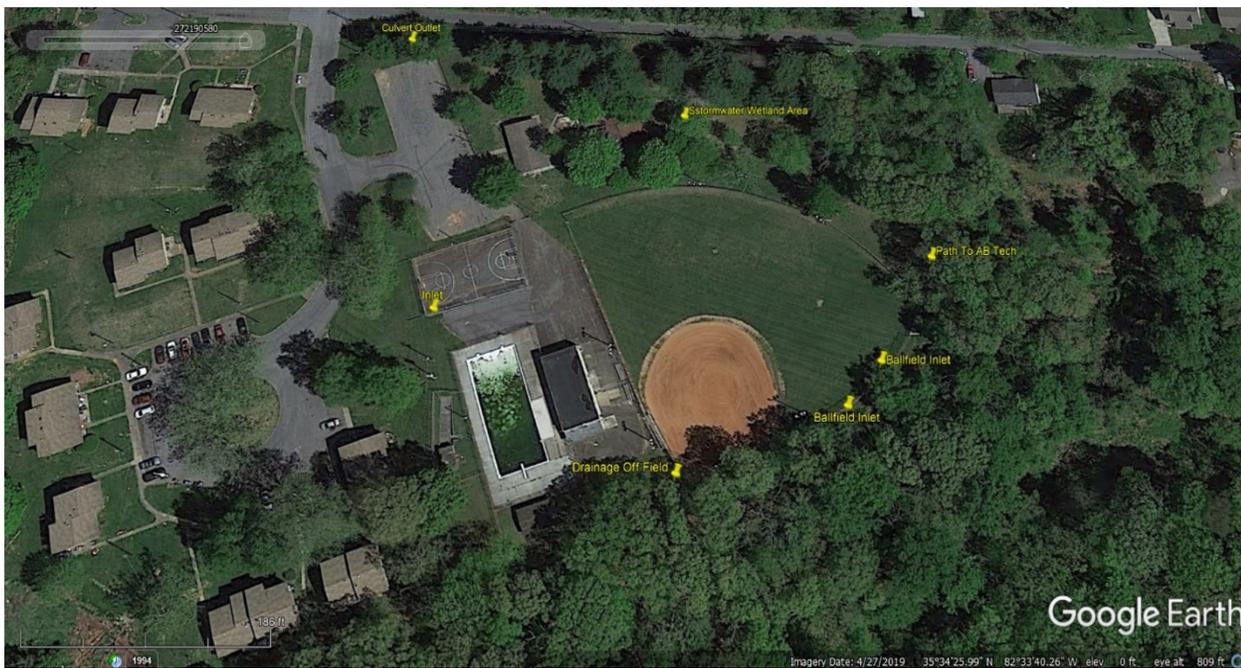
Figure 51 Aerial View of Walton Street Park

There are several opportunities to improve stormwater management at Walton Street Park, improving water quality and reducing adverse impacts on the community immediately downstream of the park. The opportunities include diverting the culvert outlet at the northern end of the parking lot into a constructed series of rain gardens, constructed pocket wetlands, and grass swales, improving drainage from the areas with the existing tennis courts and pool, and improving drainage and reducing slope erosion downstream of the baseball field.
